April 14, 2006
Arc Flash Incident
Building 1006A
Brookhaven National Laboratory

Type B Accident Investigation

Judgment of Needs

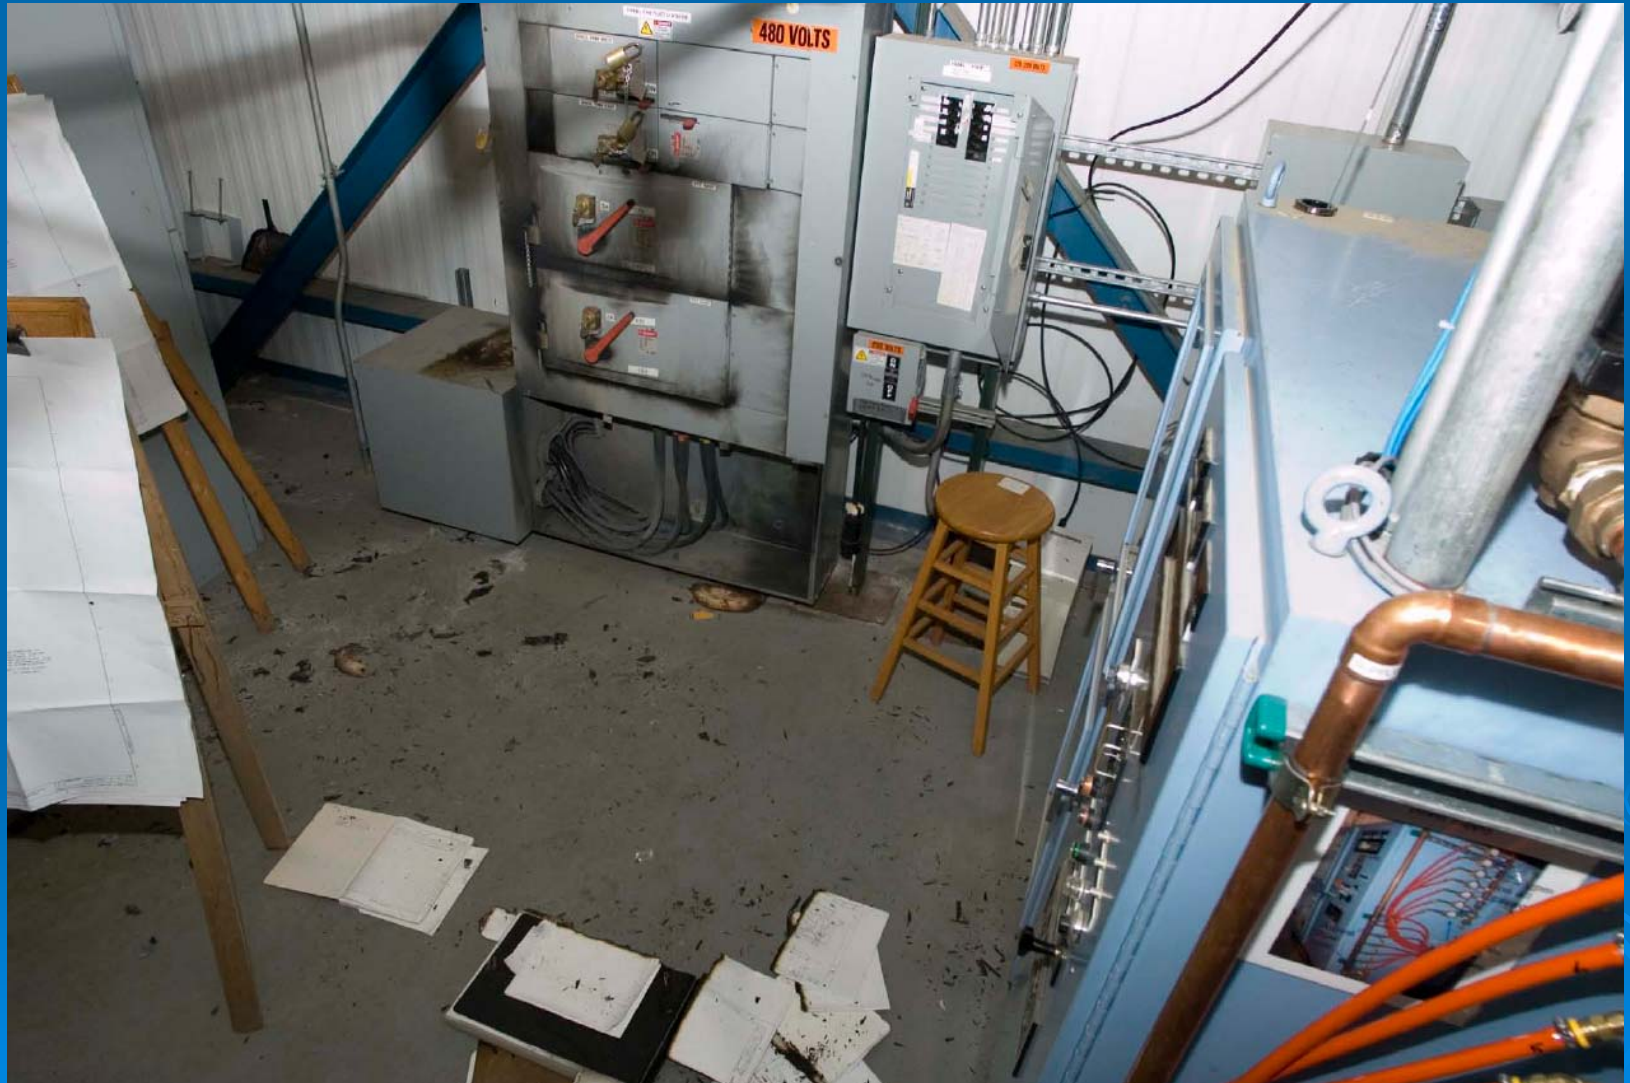
- April 14, 2006 at ~1020
- Building 1006A Mechanical Loft
- Engineer operates 480 V 400 amp disconnect switch
- Arc flash injuries:
 - 1st degree burns to head, face, chest, and hands
 - 1st and 2nd degree burns to forearms
- Switch panel destroyed

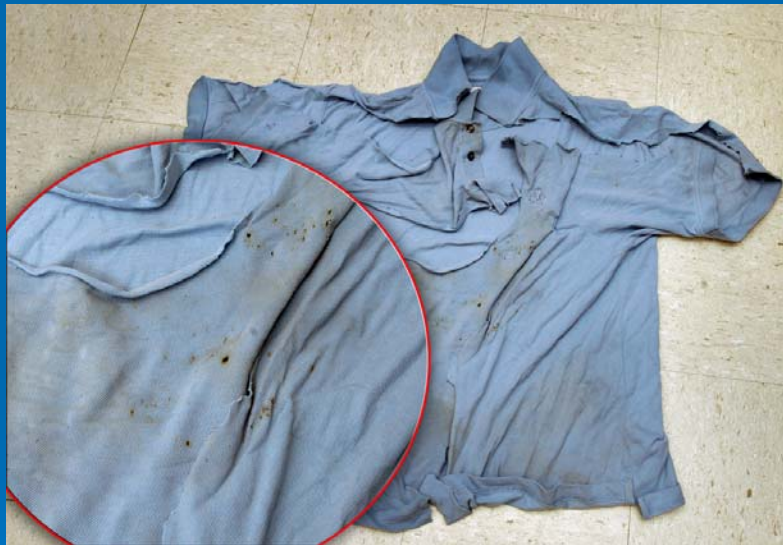
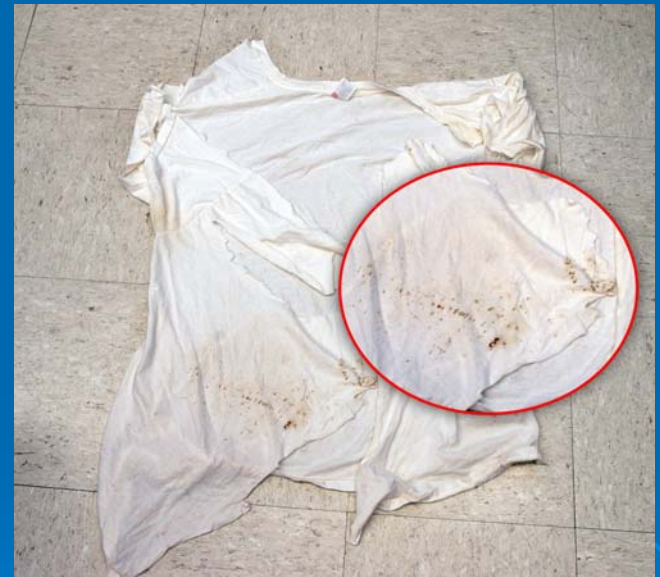
Injured Engineer's Cotton Short Sleeve Shirt and Cotton Undershirt

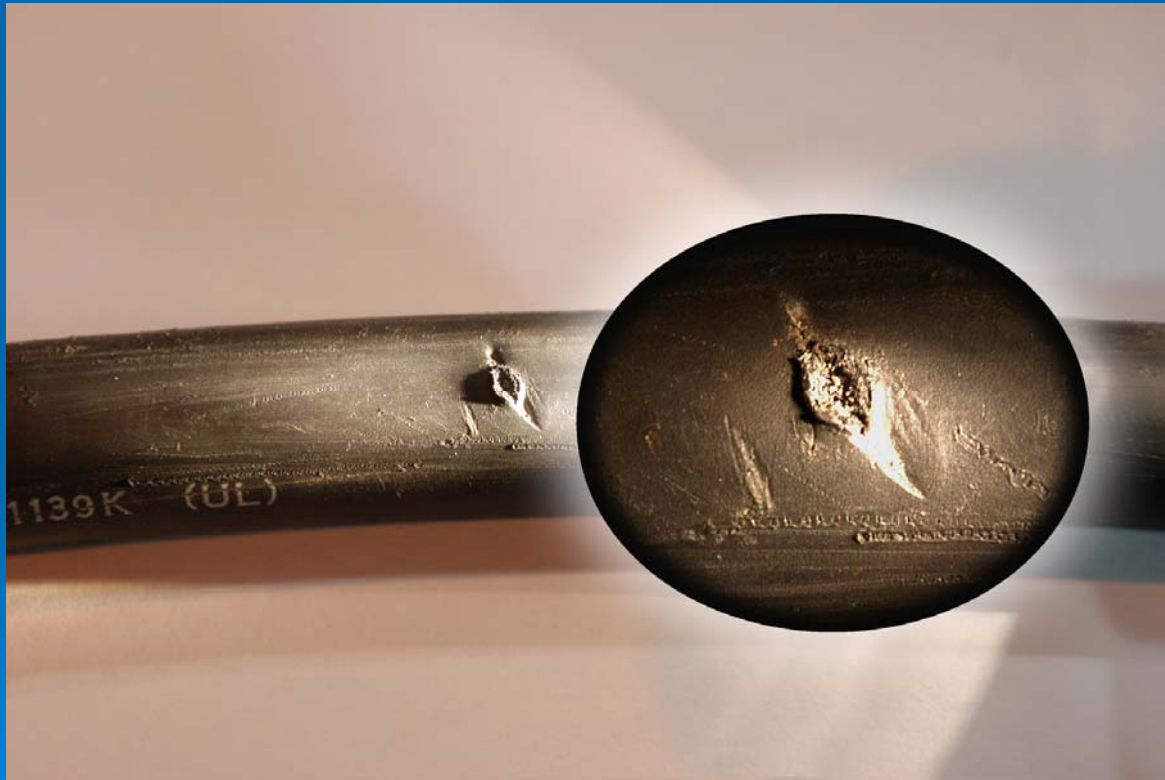
- Damaged phase C supply cable

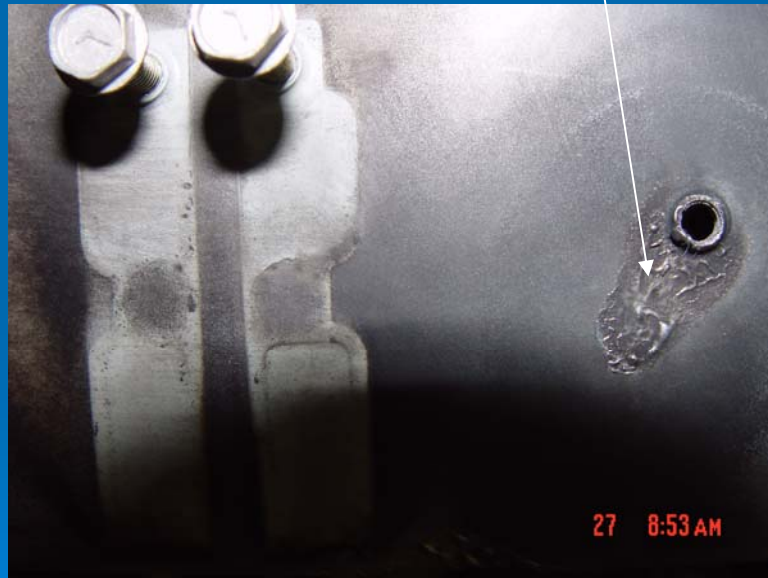
- Arc between bus bar phase “B” to ground

Arc to ground

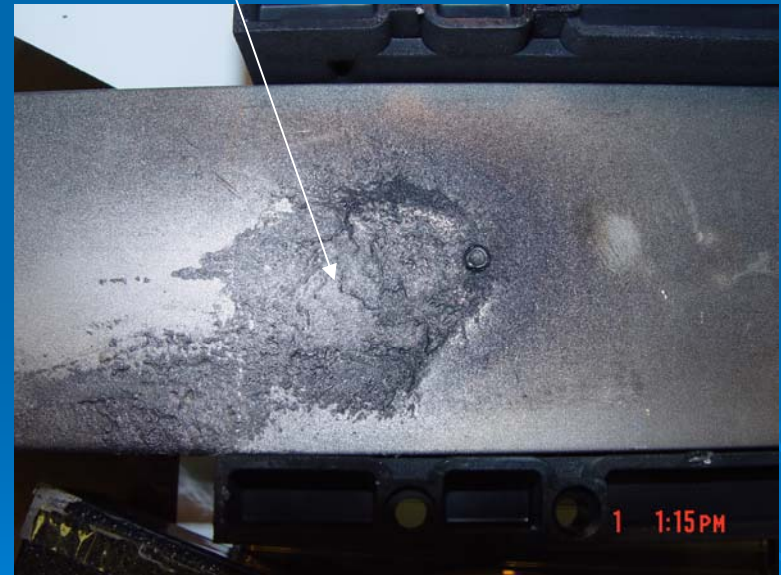
Arc to bus

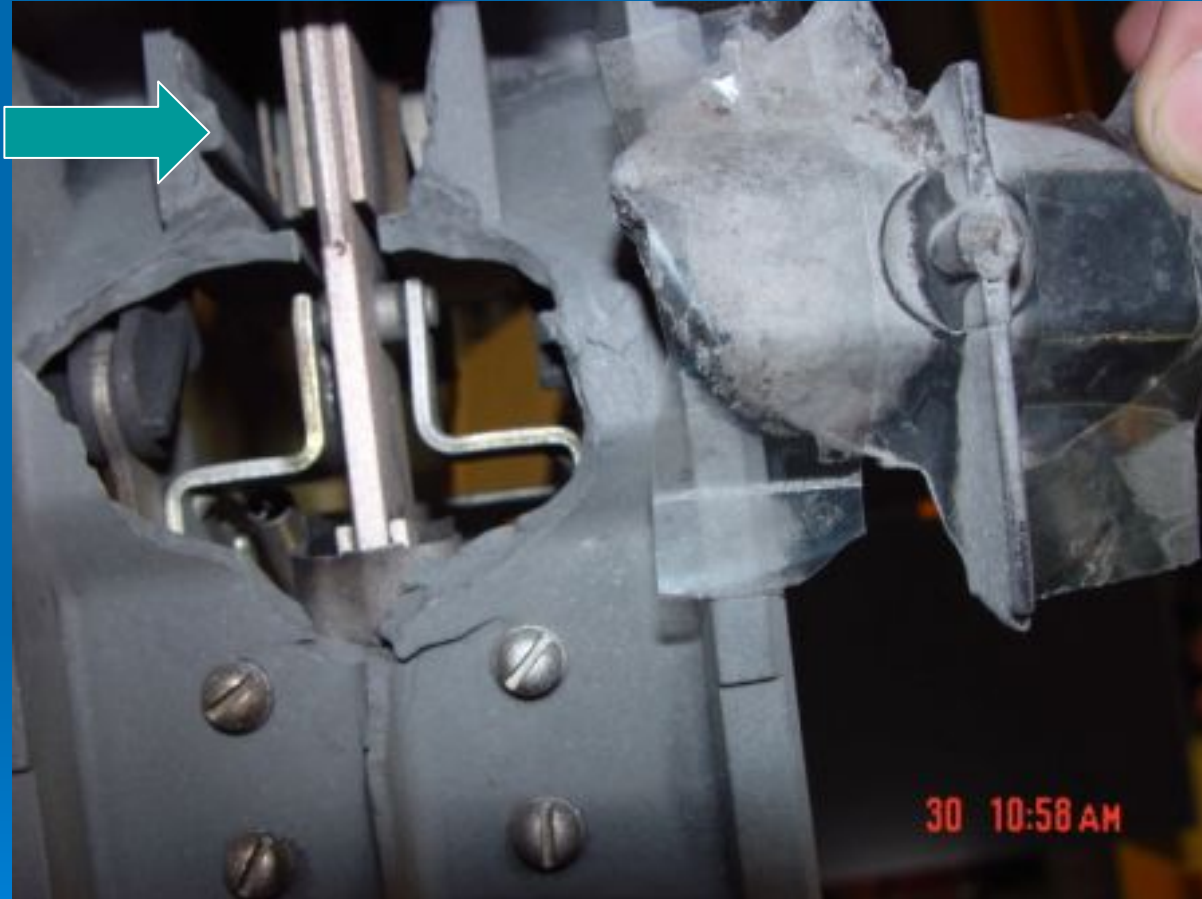
Spring Clip should
be here

Broken backing-missing spring clip-Failed unit

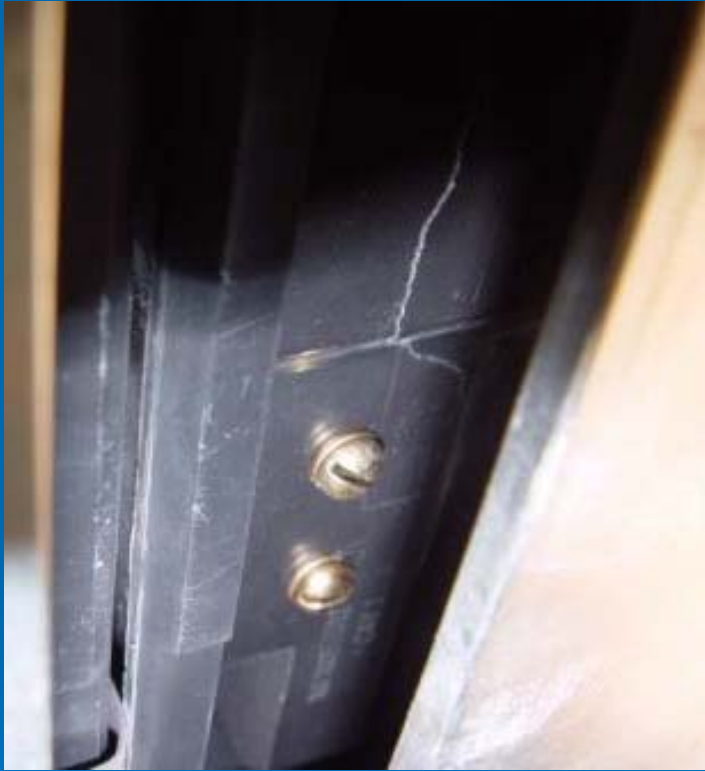
Cracks in Plastic backing after 200 operations-Back
(Reference unit)

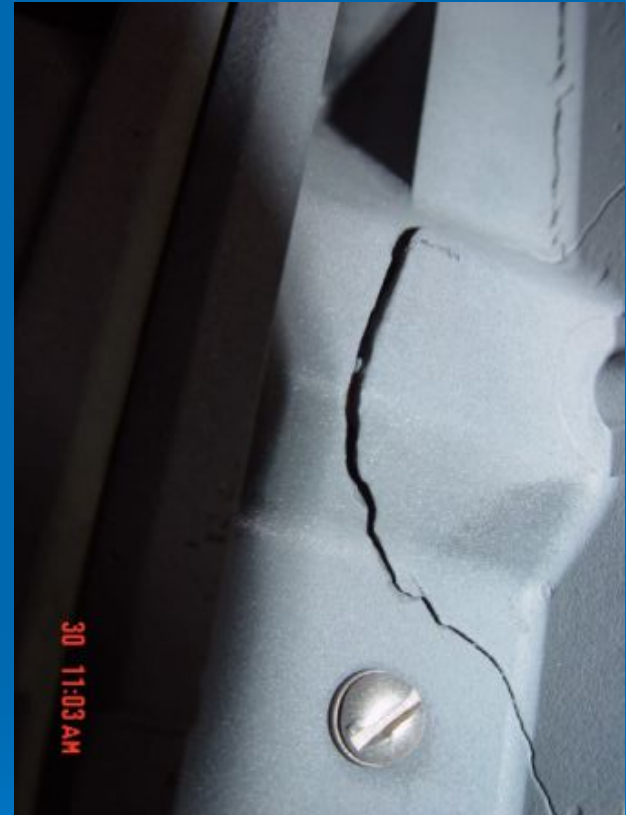
Similar crack in failed unit

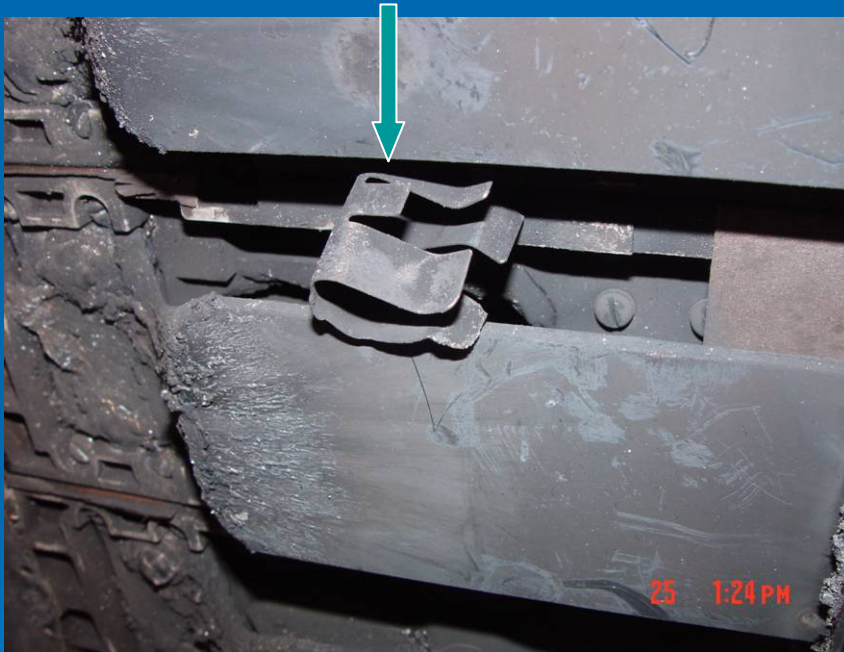
Steel Spring Clip

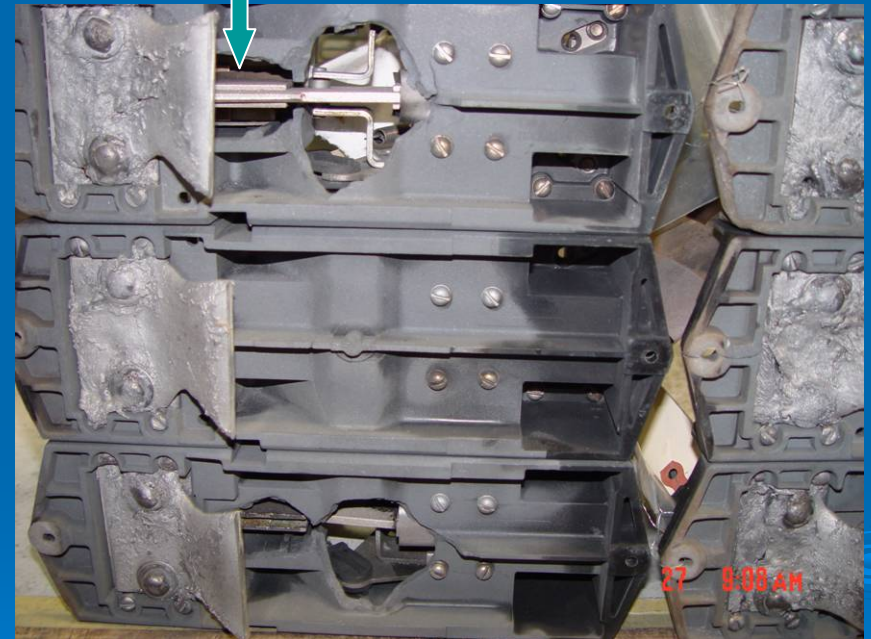
Spring Clip should be here

Damaged unit and a spring clip-bus bar is removed-this damage was hidden with bus in place

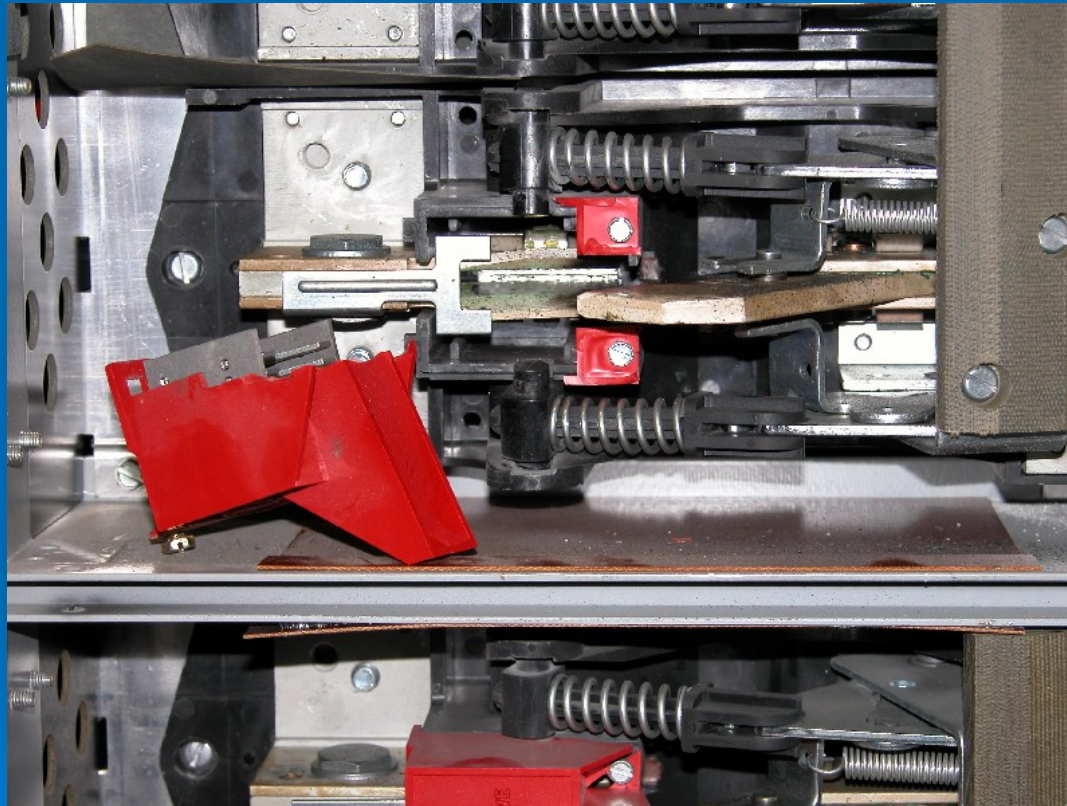
Broken arc chute in Bldg 902 switch

- Inspect GE Spectra Series Switches
